FIRE INVESTIGATION REPORT

1.1. **Incident No:** DFRMO/3000/3/4376

Address: Building [REDACTED]
AWE Aldermaston,
Aldermaston,
Berkshire
RG7 4PR

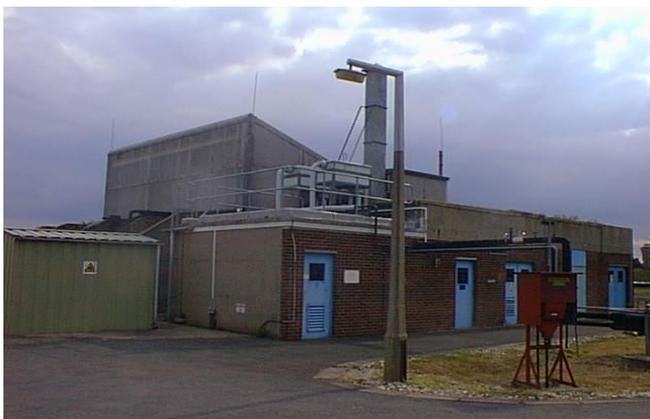
1.8. **Building Description:** The affected building ([Picture Identification: No 1 External Shot - taken prior to its refurbishment and the fire](#)) is a hardened explosive preparation facility.

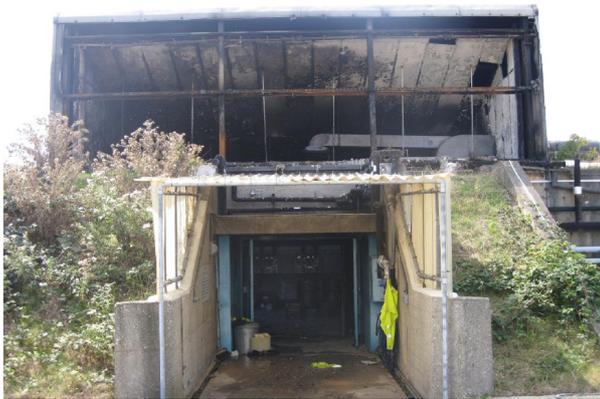
- 4.1. **Introduction:** An external examination of the scene was conducted 03 Sep 2010 ([Picture Identification: No 8 External Shot - \(16/08/10\) Front face](#)). Due to the number of hazards still contained within the building the internal examination was deferred until a later date as AWE and then HSE placed an embargo on entering the building without prior agreement.

- 4.2. **Observations:** Viewed from the outside it can be seen that the assembly room was subjected to an extreme amount of heat as can be borne out by the visible evidence. Following the consumption by fire of the low-melt panels you can see straight into the assembly room from the outside. As a result of the failure of these panels the fire would have self ventilated itself and the sudden in-rush of air would have increased its ferocity and rate of burning. There are a number of visible indicators which point to the intensity of the fire. As you face the front of the building the burn patterns indicate that the internal top right front corner of the ceiling was subjected to an intensive build up of heat. Carbon deposits and the by products of combustion have been completely burnt off and three internal ceiling panels have failed. The internal top left front corner of the ceiling also shows the visible affects of some high intensity burning. Again there are indications that the by products of combustion have been visibly burnt off. All of the steel cross members nearest to the apex of the ceiling show signs of visible twisting and warping. Lightweight cross members have little if no inherent fire resistance. Unprotected steelwork will lose approximately half of its strength in temperatures of 500-550°C. This would indicate that for a limited period of time the temperatures were in excess of this. The worst of the warping occurred in the top left hand corner of the front face of the building. However the evidence would suggest that these steel cross members were not subjected to these temperatures for a long period of time as the roof structure on the whole appears to be structurally sound. The most likely cause for the heat generation within this part of the compartment is that radiated heat spontaneously ignited the 1.5 kg of NC, located directly across the room from the point of origin. Prior to the fire this NC was placed beneath the table where the weighing scales are situated. On igniting, the NC propelled itself high into the top left corner. On hitting the corner the NC continued to burn fiercely with high intensity, radiating heat and energy causing the left hand steel brace to warp to a greater degree than the other cross members. The double wooden doors leading into the assembly area are charred from the inside. These probably continued to burn for a longer period of time once the MEK and NC was finally consumed. Much of the damage to these doors is attributed to the Remote Observation Vehicle (ROV) which had to force entry into the room.

- 4.3. Conclusion of the External Examination: The internal photographic and visual external evidence indicates that the front portion of the assembly room nearest to the low melt panels suffered the greatest exposure to heat and flames. The course of the fire took it away from the rear wall and three known wooden boxes containing a test sample of explosives and another of dry NC. There was little if no damage to the outer surfaces of these boxes. The evidence so far suggests that although the fire was initially intense it did not burn for long.

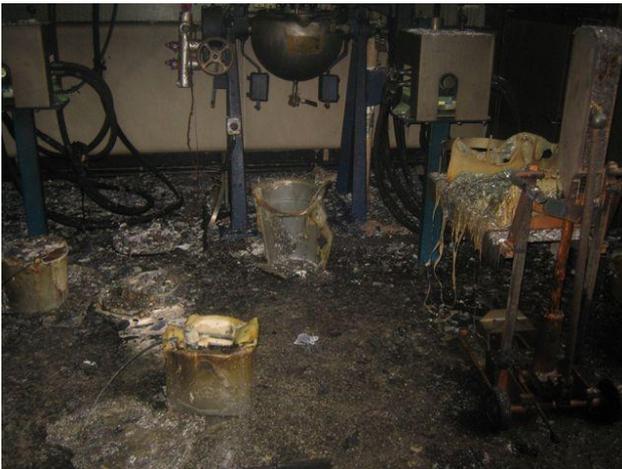
(Picture Identification: No 26 Internal Shot - Suspect seat of the fire).

- 5.2. Observations: The area of immediate interest was where the witnesses first indicated the source of the initial vapour ignition. This area is situated between the remains of the five plastic melted buckets. In the early stages of the fire one of these buckets was known to contain 18 litres of burning MEK/NC solution. Two other buckets were also known to have each contained a further 18 litres of MEK. There is clear evidence on the floor between these buckets to indicate that an ignitable liquid has been consumed in the fire. These buckets show signs of directional heat transference (or direct burning), they are damaged far greater on one side than the other. Machinery accessories in close proximity are also melted and disfigured due to the rapid build up of heat. Wooden crates situated nearest to the scene of origin are charred on the surfaces directly facing the burn patterns on the floor. The further you move away from these burn patterns the charring is reduced. Heavy smoke staining indicates that large volumes of un-burnt black fire gases were produced in the initial stages of the fire. All horizontal and vertical surfaces have black oily soot deposits adhered to them from the resultant combustion. Ceiling debris and wall plaster has fallen onto the floor and on top of work benches and other such flat surfaces. Paper

- 5.3. Conclusion of the Internal Examination: The assembly room was confirmed as being the room of origin. The failure of the original bucket to maintain its structural integrity whilst on fire caused the flame front to spread out quickly along the floor due to its now increased surface area. The evidence of a clearly defined pool pattern supports this premise as flammable liquids leave behind sharp distinctive burn patterns. The continuing fire caused the other two containers of MEK to melt adding further fuel to the fire.

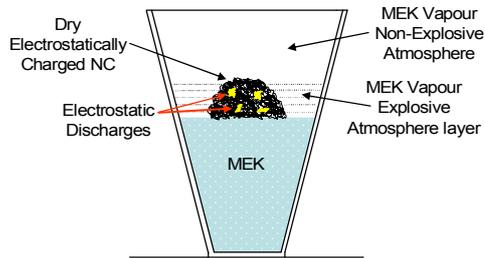
- 7.1 Electrostatic Discharge (ESD): A technical investigation team made up of explosive specialists, chemists and scientists (from AWE) considered a wide range of causes for the vapour ignition which included chemical reaction, friction, autocatalytic exothermic decomposition and ESD. From their investigations they concluded that the ignition of MEK vapour by ESD during the adding of dry NC was the most probable cause of ignition.

- 7.2 A diagrammatic schematic below provides a visual representation of this explanation. A greater explanation is provided under the heading conclusion.

- 8.1. The technical team concluded that the most credible and probable scenario for the ignition of the MEK/NC solution: was the ignition of MEK vapour; *via* an Electro Static Discharge (ESD) within the NC, resulting in a vapour explosion. The manufacturing process for the NC lacquer includes the drying of the IPA wetted NC. Handling and weighing of the dry NC into 375 gram bundles and then packaging in normal resistive polyethylene bags can generate ESD on the NC fibres. The dry NC will acquire a significant ESD charge from contact and friction against the bag, tearing of the NC from the bundle and loosely dividing it as it is added to the MEK generates a further charge and is most likely to be the cause of the ESD event. These ESDs will have been occurring throughout the process once the NC was dried. Approximately 100 grams of dry NC was torn from the 375 gram bundle and divided into pieces and added to the MEK contained in the mixing bucket. This NC would then initially float on the liquid surface within the explosive atmospheric layer and solvate. The rationale is, in this situation the NC underwent a charge neutralisation by ESDs and these discharges ignited the MEK vapour/air mixture. For this to occur the correct mixture of flammable vapour to air ratio needed to be present. Given the small surface area within the confines of the bucket and that MEK vapour is heavier than air it remains plausible. The resultant sudden deflagration would be consistent with the events observed by the witnesses.
