Agricultural Building Survey & Structural Assessment

Lodge Barn
Cromer Road
Hainford
Norfolk

May 2017 – Version 1

Project Name: Lodge Barn, Cromer Road, Hainford, Norfolk NR10 3AT

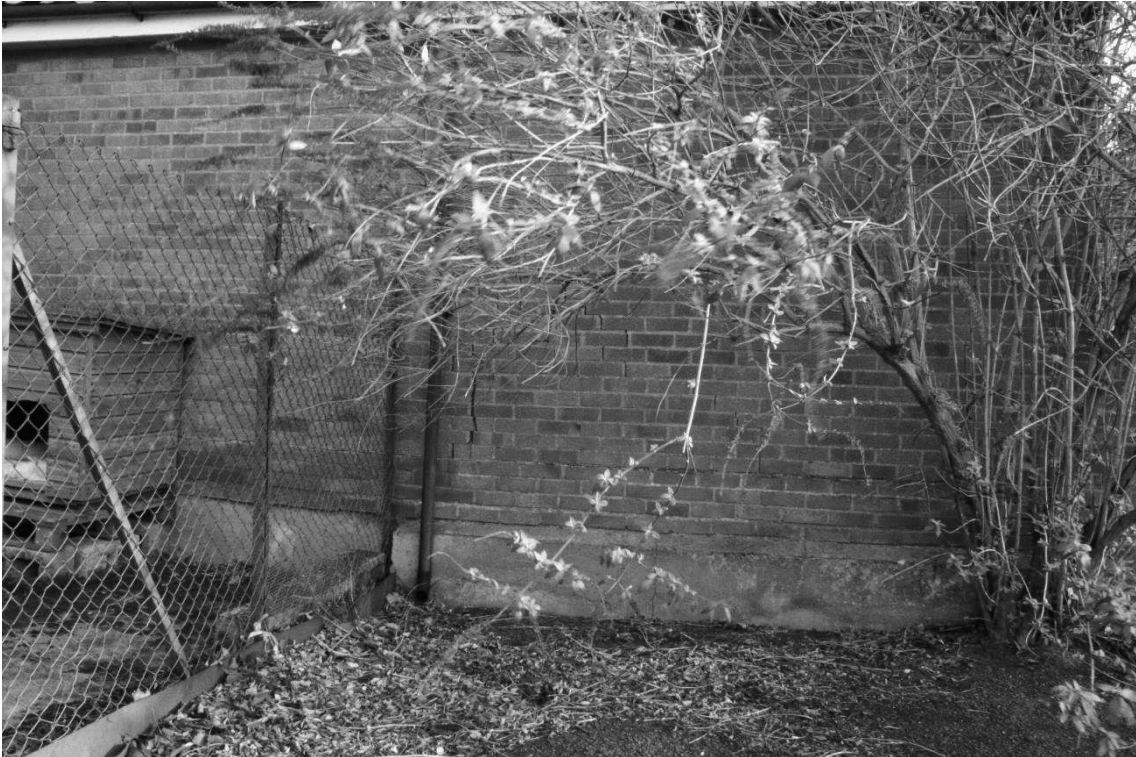
- 4.24 The rear store is of similar construction and in principle remains suitable for continued similar use. There is, however, significant cracking to the right flank wall consistent with a moderate degree of foundation movement. The movement is consistent with the location of the rainwater downpipe serving this elevation and it appears that water discharging direct to the ground and close to the foundations at this point has led to softening of the underlying soils over time. In turn this has allowed downwards movement of the foundations and consequent cracking to the overlying wall.

- 4.25 Given that the subsidence movement has probably been ongoing for some considerable period of time, it is unlikely that mitigation measures (i.e. the provision of a suitably located soakaway) alone will not suffice as the ground conditions are doubtless too deteriorated. It is therefore likely that localised underpinning of the affected wall and possible associated reconstruction of the adjoining floor slab will be required. Mass concrete underpinning installed incrementally and extending to competent soils at depth should be used, followed by crack stitching incorporating bed joint masonry reinforcement or localised wall reconstruction, if warranted.

6. External cracking to right side of store

- 5.8 The localised subsidence damage to the right flank wall of the rear store building requires a more extensive method of repair, as discussed in para. 4.25. Once the recommended works have been completed, there is no reason to suggest any underlying problem will persist.

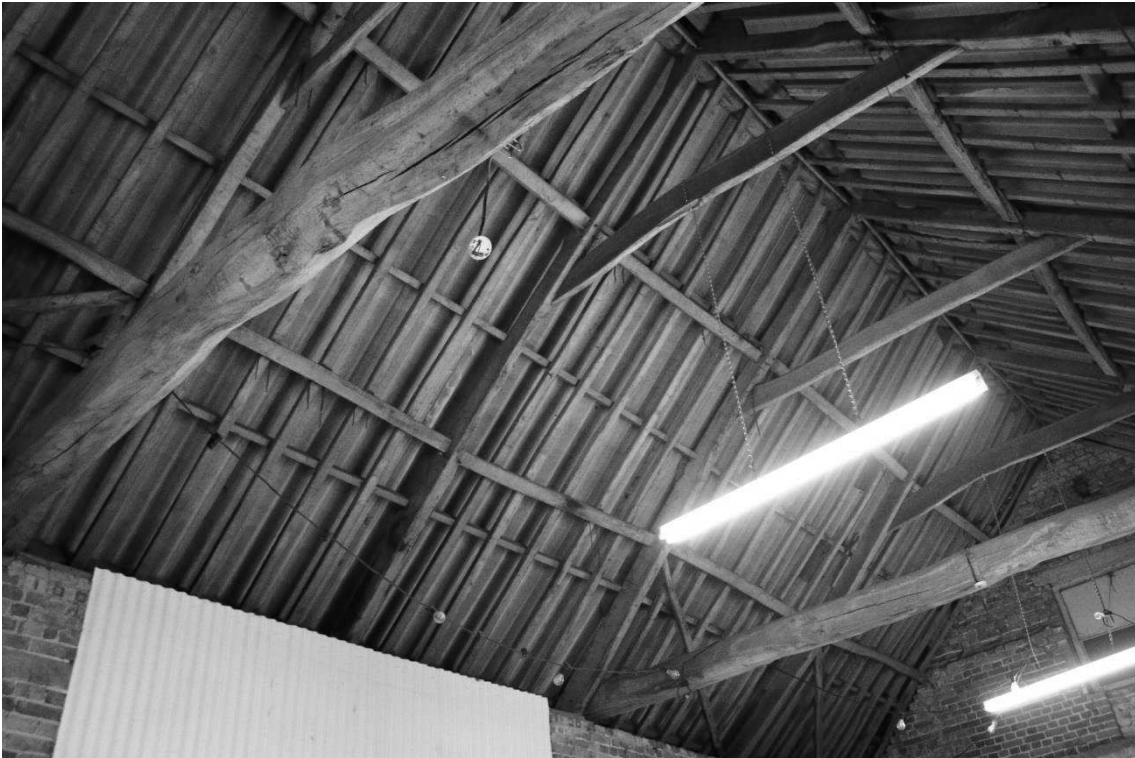
- 4.8 Viewed internally, the principal roof timbers appear in good condition and remain serviceable for continued use. Their viability is borne out in the evident good condition and alignment of the current roof sheeting. Replacement sheeting should take the form of composite profiled steel sheeting panels or something similar, where the self-weight will be no greater than the existing sheeting. Replacement with a traditional tiled covering may compromise the existing structure and would require further detailed analysis to confirm its continued integrity.

7. General view of barn roof structure

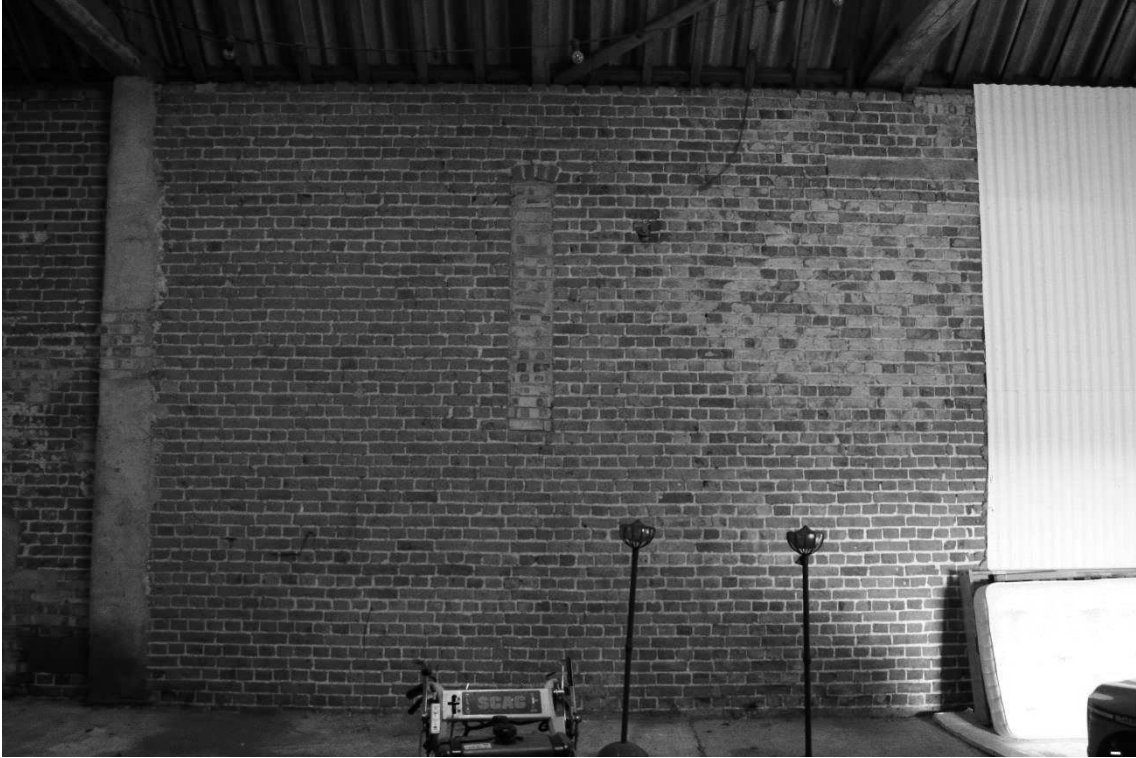
9. Typical internal view of front wall showing infilled door opening

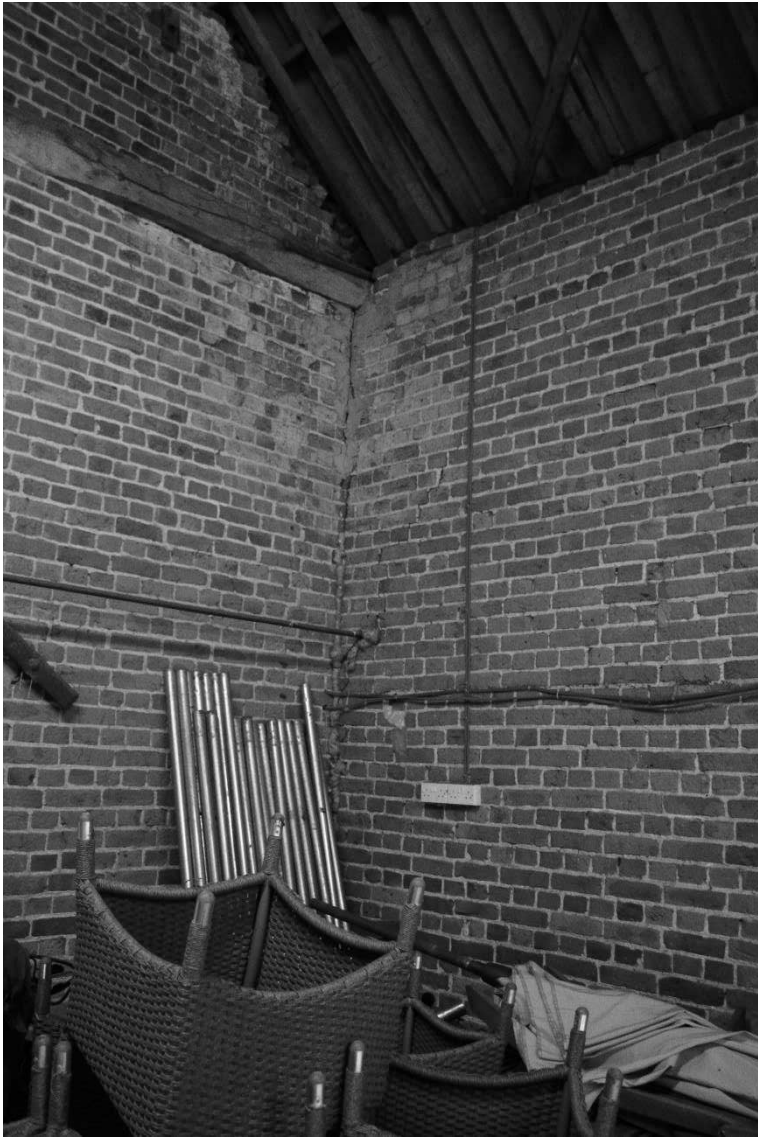
- 4.17 Further vertical cracking is evident in the rear left corner wall junction up to 10mm wide, which appears to be of some age. This appears to have been subject to previous remedial tying in the form of a 25mm diameter steel bar installed across the building close to the left hand gable wall some 2.2 metres above floor level. The left hand gable wall is otherwise in a satisfactory condition.

11. Cracking to rear left corner of barn showing remedial tie rod

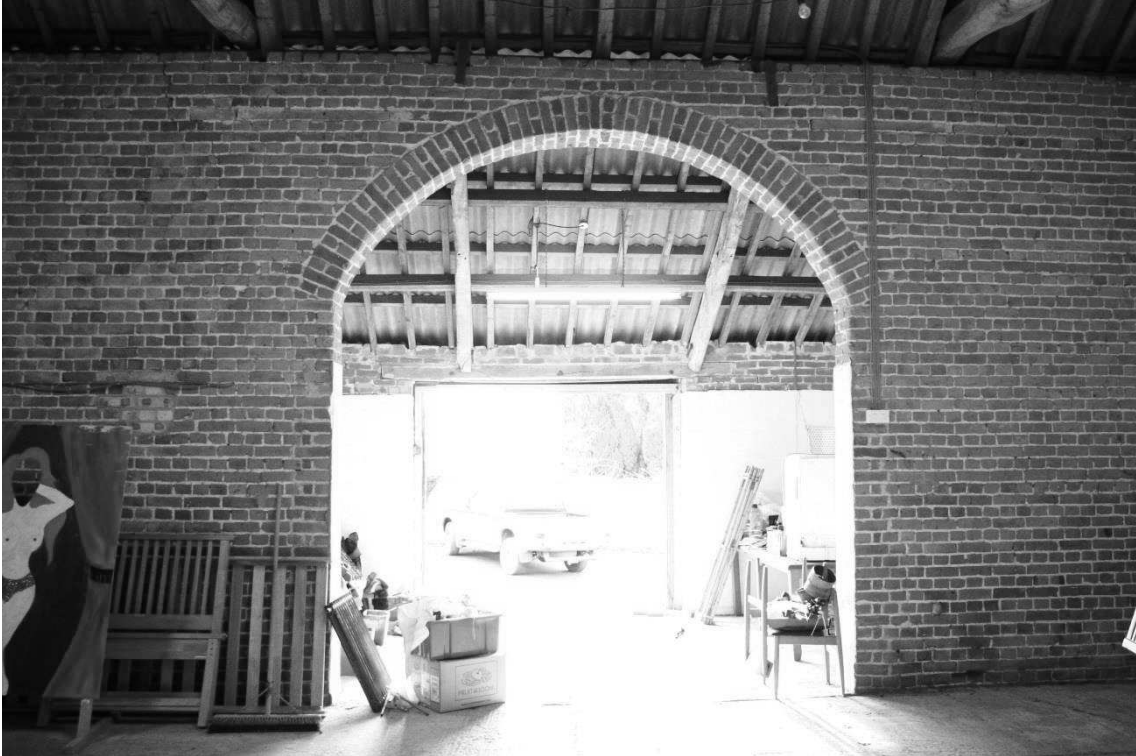
- 4.14 The rear wall has similarly been subject to past brickwork repair and patched render. The arch ring above the rear dominant opening appears to have suffered little significant distortion and presents an even profile. It is likely, however, that it has settled slightly at some stage given the minor cracking present above each arch spring.

12. Archway to rear elevation through to offshoot

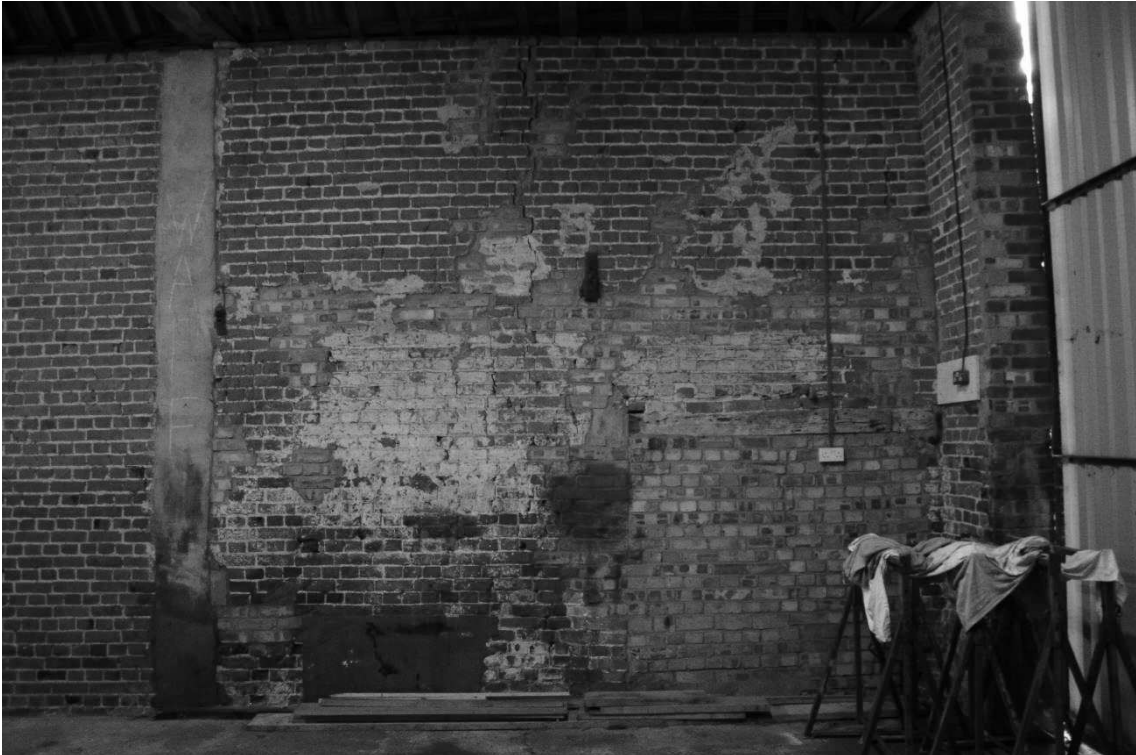
- 4.15 Diagonal tapering wall cracking up to around 12mm wide is present in the right hand 25% of the rear wall emanating from floor level and extending towards the right hand corner of the building. This could be indicative of being the result of slight foundation movement at the rear right corner, in all probability attributable to ground softening due to rainwater ingress, either due to the soakaway being located too close to the building or being ineffective or non-existent.

13. Internal cracking to right hand end of rear wall

- 4.16 The cracking noted, whilst of modest proportions, should be suitable for simple repair by repointing and the introduction of masonry bed joint reinforcement to restore structural integrity provided mitigation measures to prevent further foundation movement are also implemented. This would involve the provision of a new soakaway for roof water drainage located at least 5 metres away from the building structure.

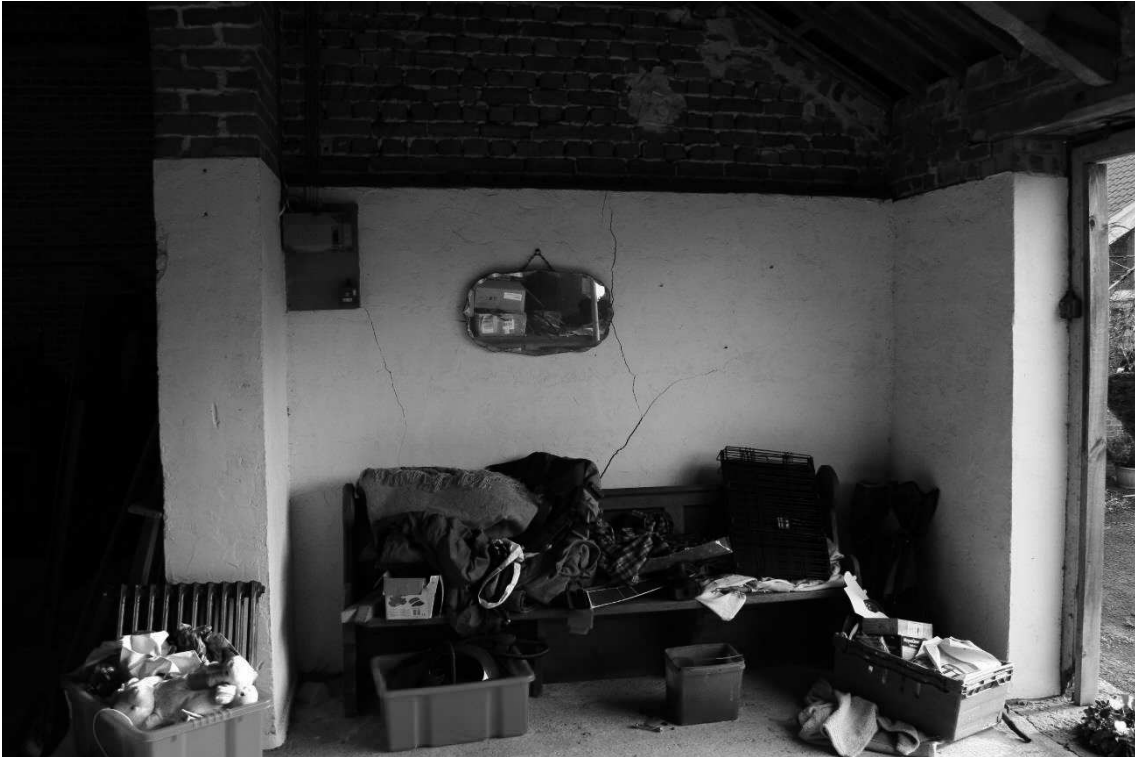
- 4.21 Internally, the left end wall of the offshoot is rendered and this exhibits modest cracking, in all probability consistent with the use of hard sand/cement materials rather than lime based materials, which are more tolerant of slight movements and consistent with the more pliable underlying construction. It is recommended that this render is removed and replaced with more appropriate materials if required. There is no evidence of consistent damage in the underlying masonry.

15. Cracking to internal render of rear offshoot left hand wall

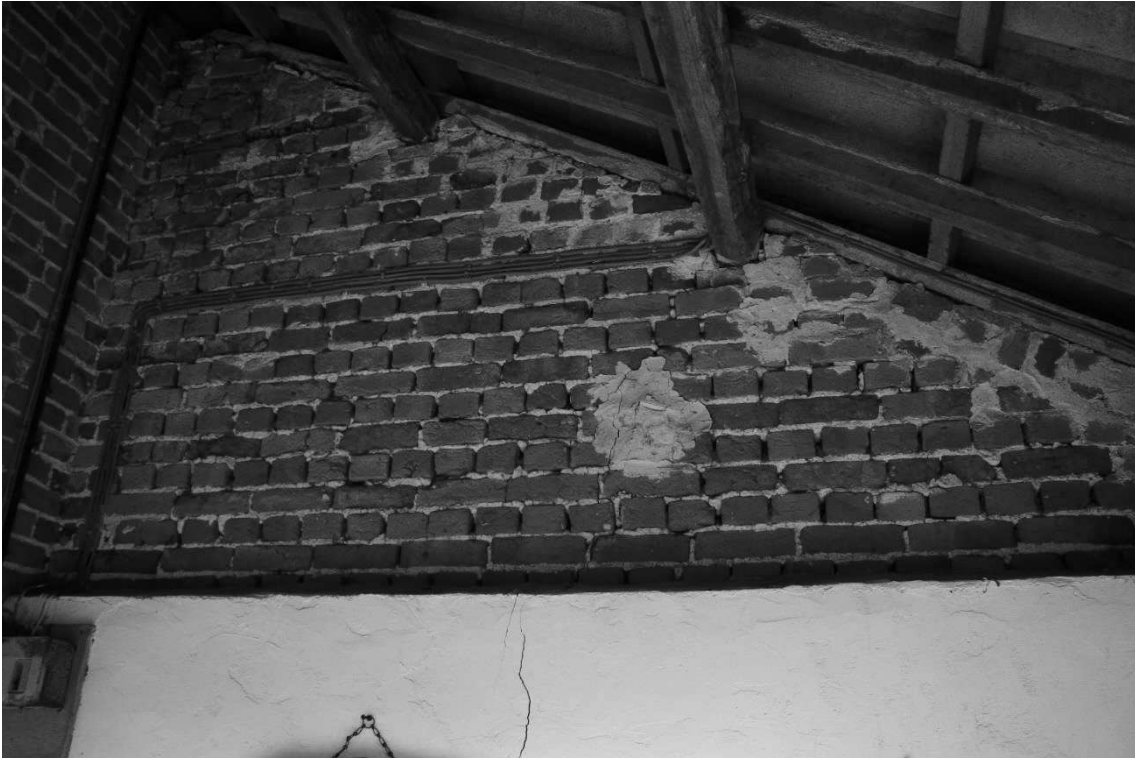
16. Weathering and mortar loss to gable peak of rear offshoot left hand wall
