## **Stream Restoration Photo Monitoring Protocol:**

The District's Department of Energy and Environment (DOEE) proposes the following stream restoration monitoring protocol in order to ensure the success of stream restoration projects. DOEE believes that this protocol can be implemented in a timely and cost effective manner.

### **Photo Documentation Guide**

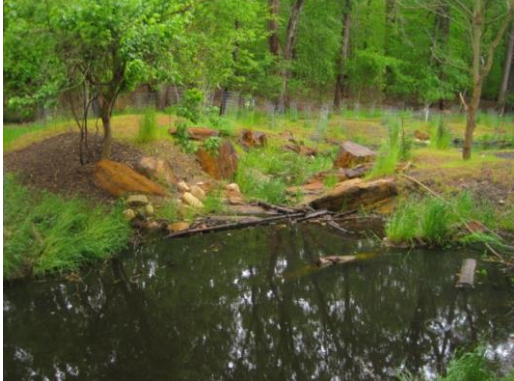
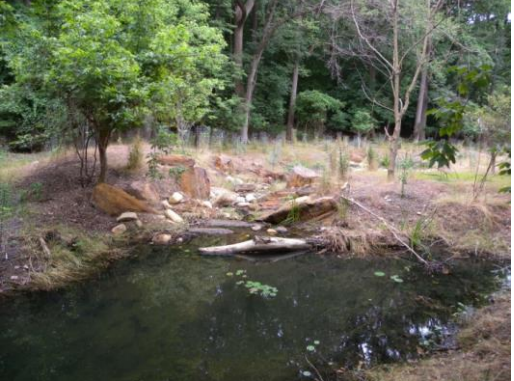
Station	Feature	Comments	Corrective Action Needed	March 2012	August 2012
0+10	Pool #1	<ul style="list-style-type: none"> <li>• Deep wide pool</li> <li>• Water lily</li> <li>• Aquatic grasses appear healthy</li> <li>• Clear water</li> </ul>	None

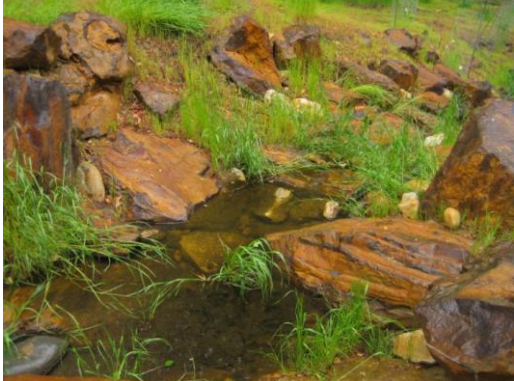
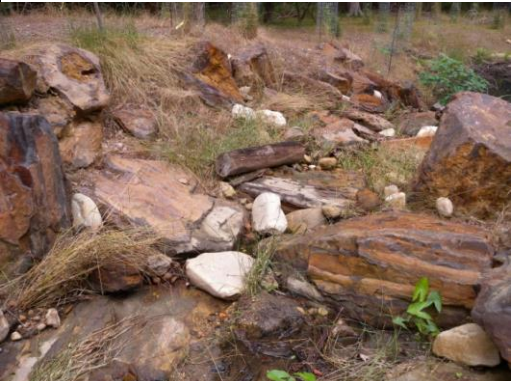
0+24	Weir #1	<ul style="list-style-type: none"> <li>• Large stable boulders</li> <li>• Good riffle cascade into downstream pool</li> <li>• New large woody debris</li> <li>• New lily vegetation</li> <li>• Healthy riparian growth</li> </ul>	None; monitor vegetative groundcover to ensure plant growth

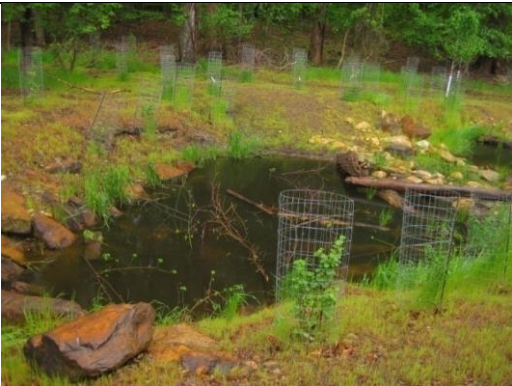
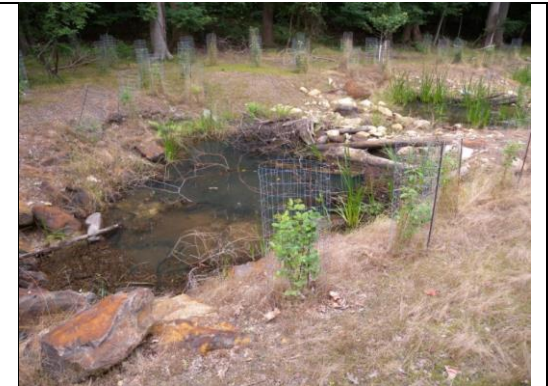
Pool #2	<ul style="list-style-type: none"> <li>• Good stable pool</li> <li>• Vegetation within and outside</li> <li>• Clear water</li> </ul>	None; monitor vegetation

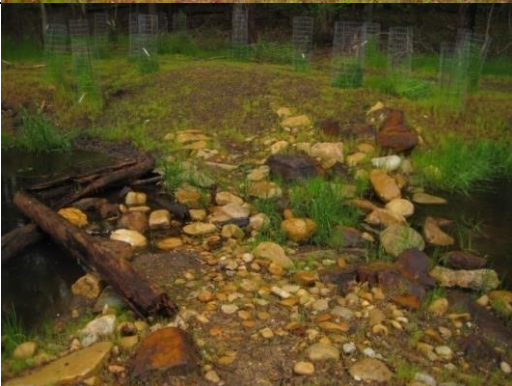
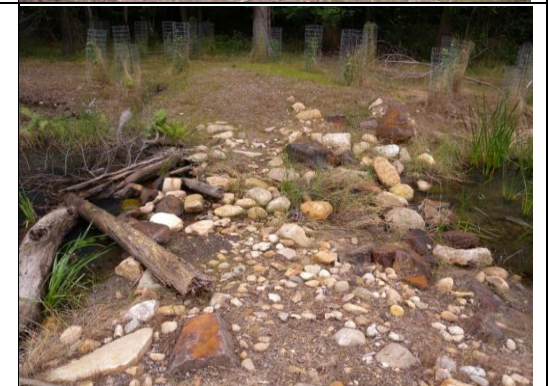
Weir #2	<ul style="list-style-type: none"> <li>• Good stable condition</li> <li>• Low to no flow over weir</li> </ul>	None; monitor vegetation
