FIRE INVESTIGATION REPORT

1.1. **Incident No:** DFRMO/3000/3/4376

Address: Building [REDACTED]
AWE Aldermaston,
Aldermaston,
Berkshire
RG7 4PR

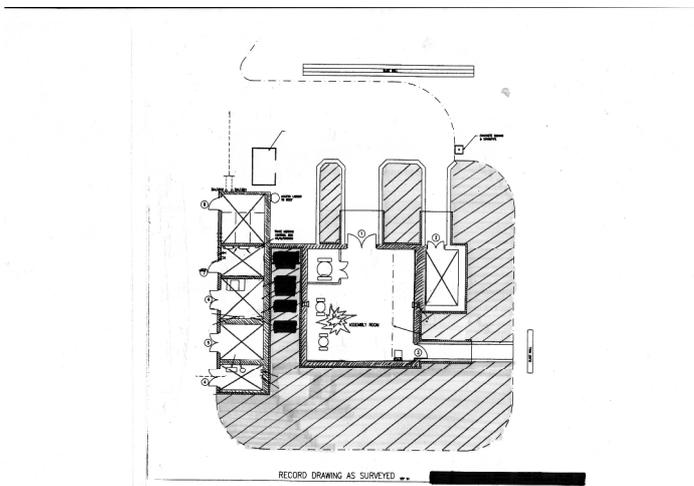
- 1.9. Its design consists of seven separate compartments which can only be accessed from the outside, with an approx floor area totalling 200m². The largest room is known as the assembly room and this room contains an inner room known as the 60 gallon mixing room. The assembly room is surrounded on three sides by substantial earth works which are designed to contain laterally an explosive event; channelling any blast wave upwards through the lightly constructed roof. The earth works are constructed all the way to the top of the external walls where these join with the roof structure. The roof is designed in the shape of a right angled 90 degree triangle (which slopes downwards from front to rear). The front vertical face of the roof structure is constructed of a frame work of thin steel cross-members which are covered by low melt plastic panels. The external roof cladding is thought to contain asbestos and this also is lightly constructed. The main entrance into the assembly room consists of a double door situated behind a blast wall sufficiently far enough away to allow for the parking of a vehicle for deliveries. To the rear left hand corner of the assembly room (as you face it) is a single door fire exit.
