Agricultural Building Survey & Structural Assessment

Lodge Barn
Cromer Road
Hainford
Norfolk

May 2017 – Version 1

Project Name: Lodge Barn, Cromer Road, Hainford, Norfolk NR10 3AT

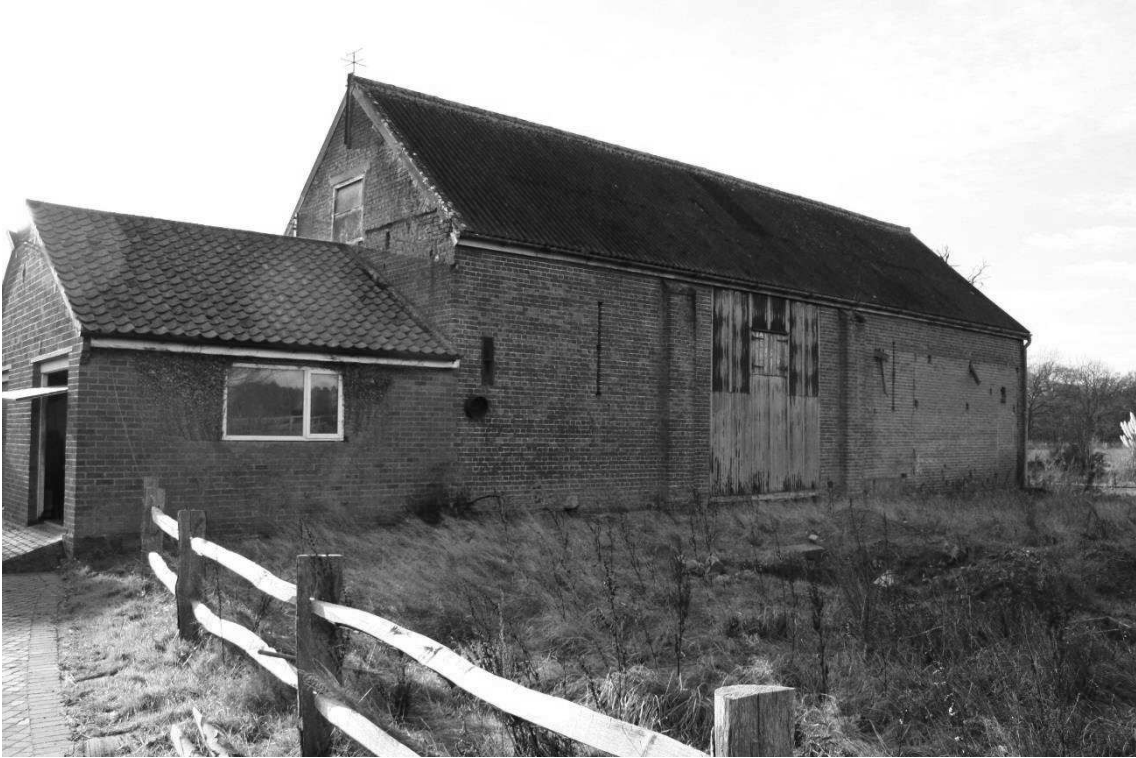
- 4.19 External inspection of the main barn walls revealed broadly similar conditions although the internal cracking to the front right corner wall junction is reflected slightly offset from the corner in the front elevation. This cracking should again be repaired by repointing and the introduction of bed joint masonry reinforcement. A limited inspection of the rear wall from within the rear offshoot revealed no additional areas of concern. An additional crack is evident in the right hand gable wall above the front end of the door opening, indicative of slight deflection of the lintel.

1. Front elevation

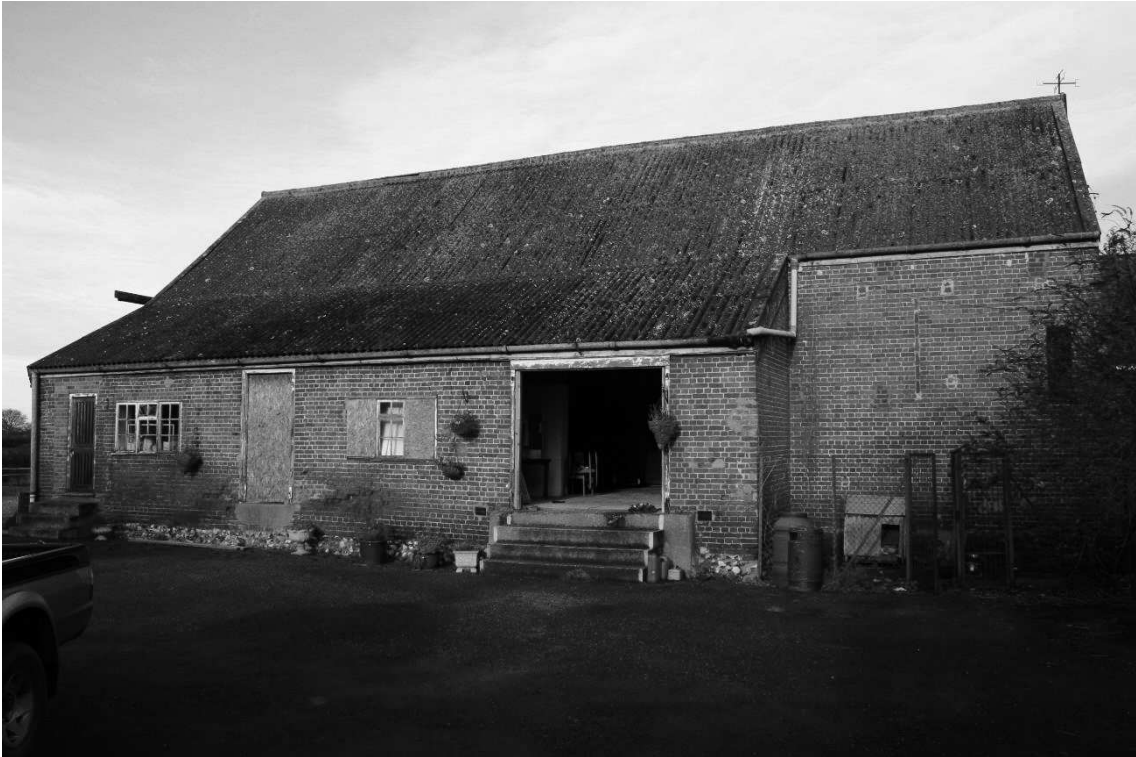
- 4.14 The rear wall has similarly been subject to past brickwork repair and patched render. The arch ring above the rear dominant opening appears to have suffered little significant distortion and presents an even profile. It is likely, however, that it has settled slightly at some stage given the minor cracking present above each arch spring.

- 4.15 Diagonal tapering wall cracking up to around 12mm wide is present in the right hand 25% of the rear wall emanating from floor level and extending towards the right hand corner of the building. This could be indicative of being the result of slight foundation movement at the rear right corner, in all probability attributable to ground softening due to rainwater ingress, either due to the soakaway being located too close to the building or being ineffective or non-existent.

2. Rear elevation

- 4.16 The cracking noted, whilst of modest proportions, should be suitable for simple repair by repointing and the introduction of masonry bed joint reinforcement to restore structural integrity provided mitigation measures to prevent further foundation movement are also implemented. This would involve the provision of a new soakaway for roof water drainage located at least 5 metres away from the building structure.

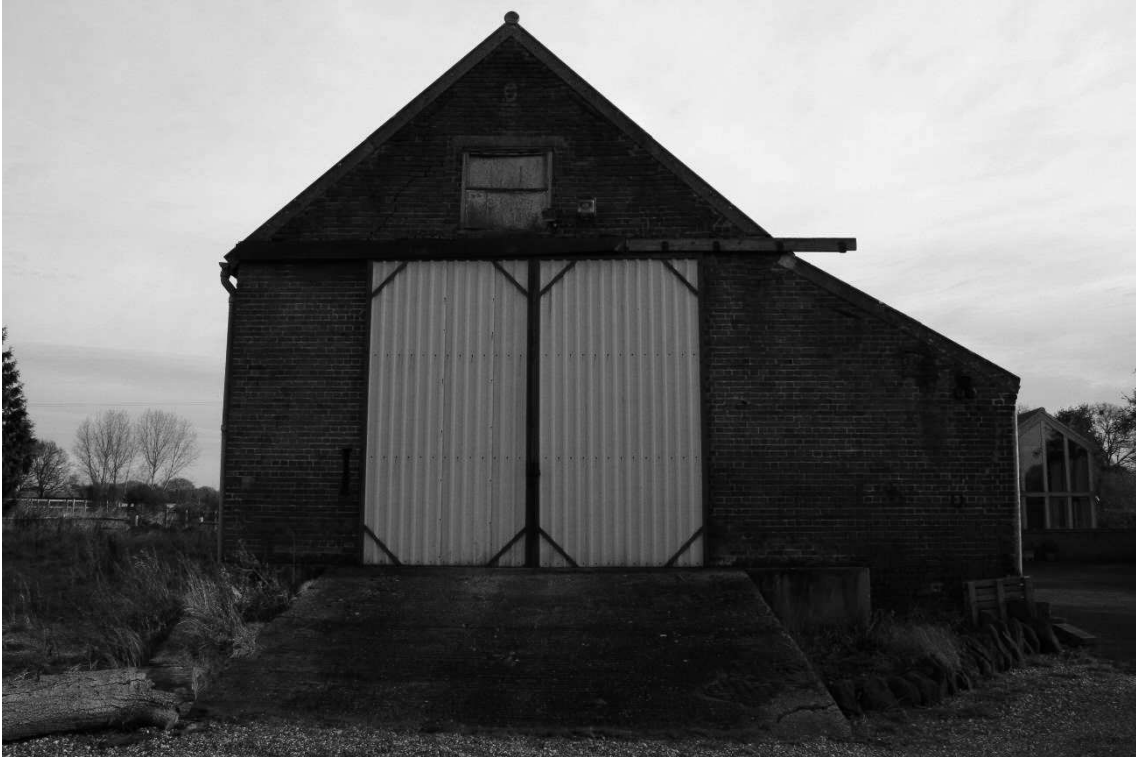
- 4.18 The right hand gable wall includes the principal operable opening into the barn which is surmounted by a concrete lintel which appears satisfactory. The low level brickwork in the returns to either side of the door opening has been subject to moderate weathering and requires repointing in lime based materials. At higher levels the brickwork appears to be in a satisfactory condition.

3. Right hand end elevation

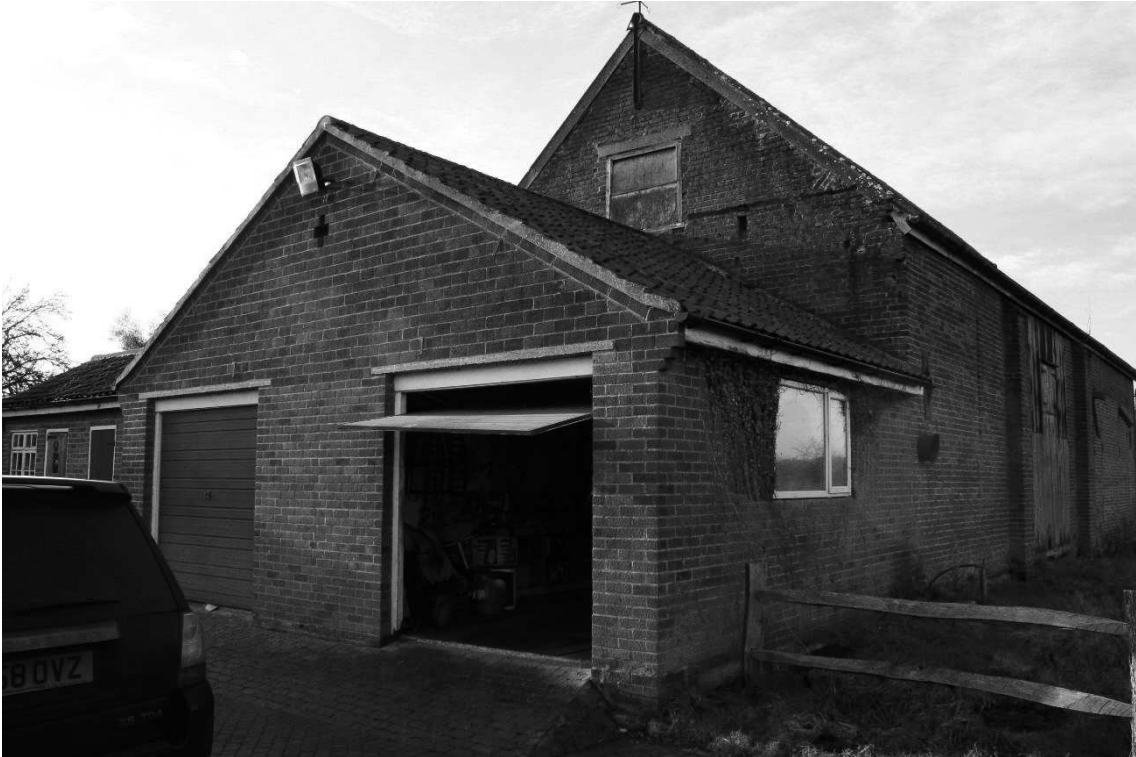
- 4.6 Rainwater goods serving the garage and store appended to the left hand end of the barn are of modern plastic construction and generally in a good condition. There is, however, no downpipe serving the front gutter of the garage and this needs to be reinstated and connected to a suitably located soakaway. The downpipe serving the left side of the store discharges to the adjoining paved surface but should ideally be piped away from the building and discharge to a soakaway.

4. Left hand end elevation and garage extension

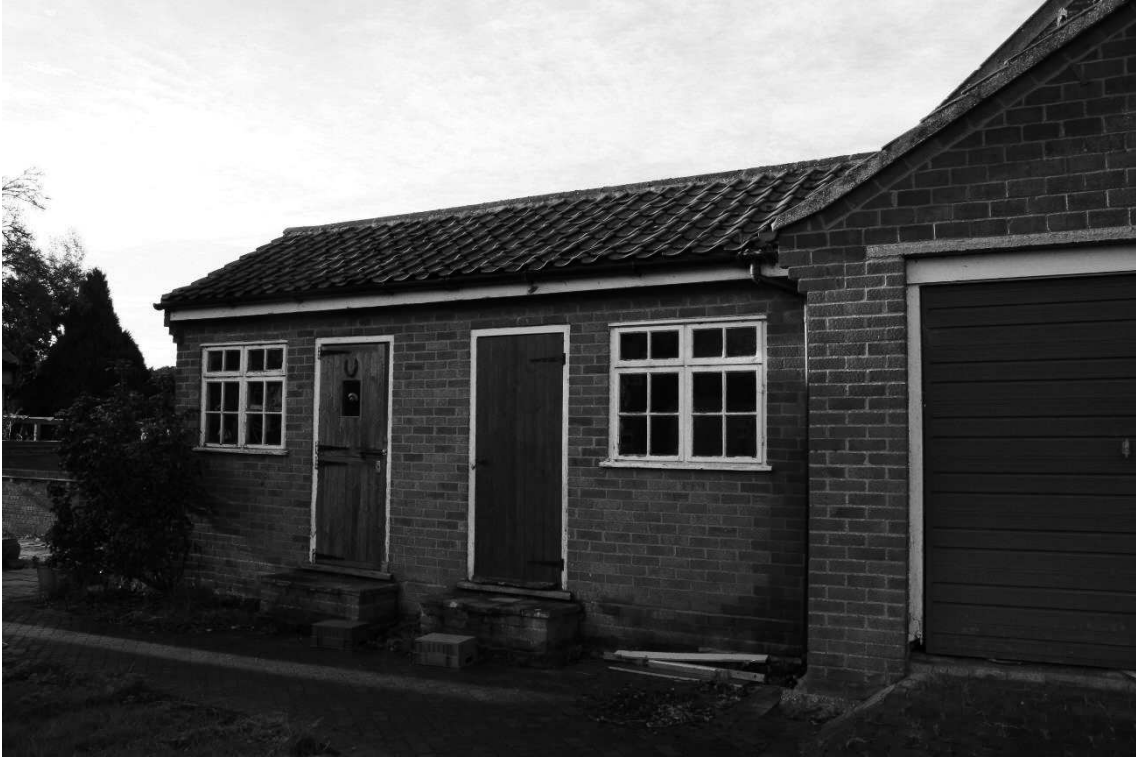
- 4.7 The downpipe serving the right side of the store and rear of the garage discharges to the ground adjoining the building foundations. This has led to softening of the underlying soils over time, leading to apparent foundation movement and structural cracking, as discussed in para. 4.24. This issue should be mitigated by piping the downpipe to discharge to a soakaway located at least 5 metres from any building.

- 4.24 The rear store is of similar construction and in principle remains suitable for continued similar use. There is, however, significant cracking to the right flank wall consistent with a moderate degree of foundation movement. The movement is consistent with the location of the rainwater downpipe serving this elevation and it appears that water discharging direct to the ground and close to the foundations at this point has led to softening of the underlying soils over time. In turn this has allowed downwards movement of the foundations and consequent cracking to the overlying wall.

5. Rear store extension to garage

- 4.25 Given that the subsidence movement has probably been ongoing for some considerable period of time, it is unlikely that mitigation measures (i.e. the provision of a suitably located soakaway) alone will not suffice as the ground conditions are doubtless too deteriorated. It is therefore likely that localised underpinning of the affected wall and possible associated reconstruction of the adjoining floor slab will be required. Mass concrete underpinning installed incrementally and extending to competent soils at depth should be used, followed by crack stitching incorporating bed joint masonry reinforcement or localised wall reconstruction, if warranted.

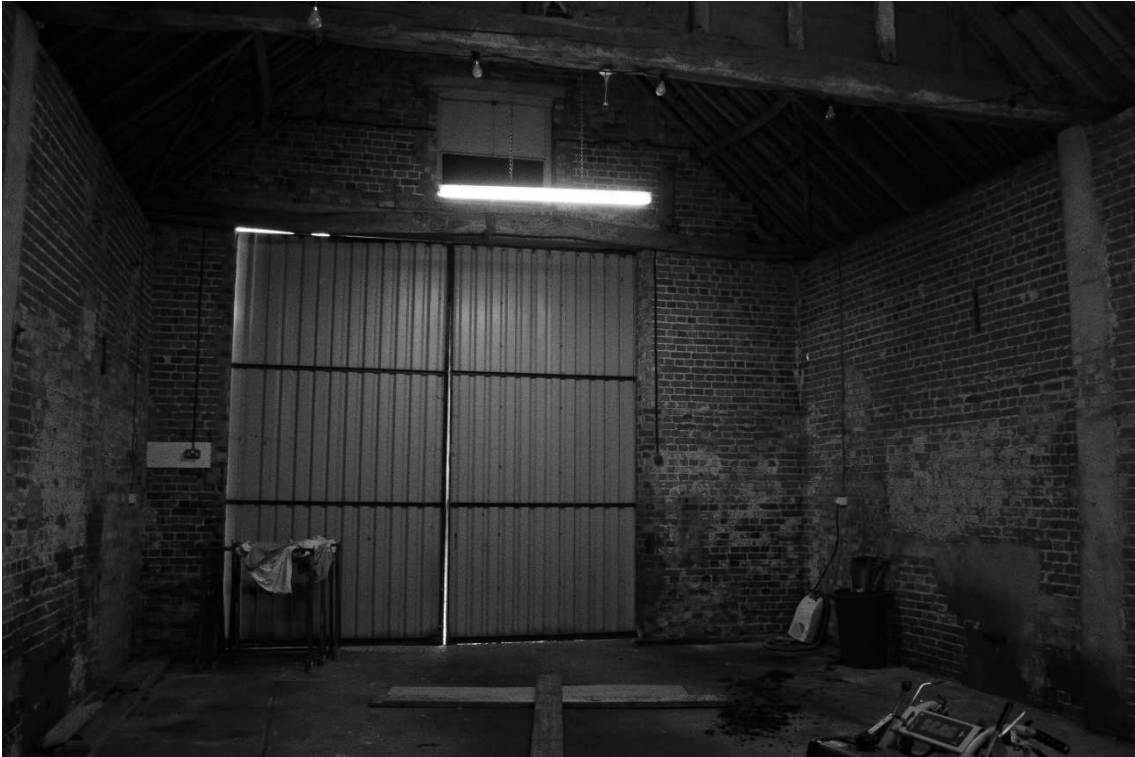
8. Internal view of right hand end wall

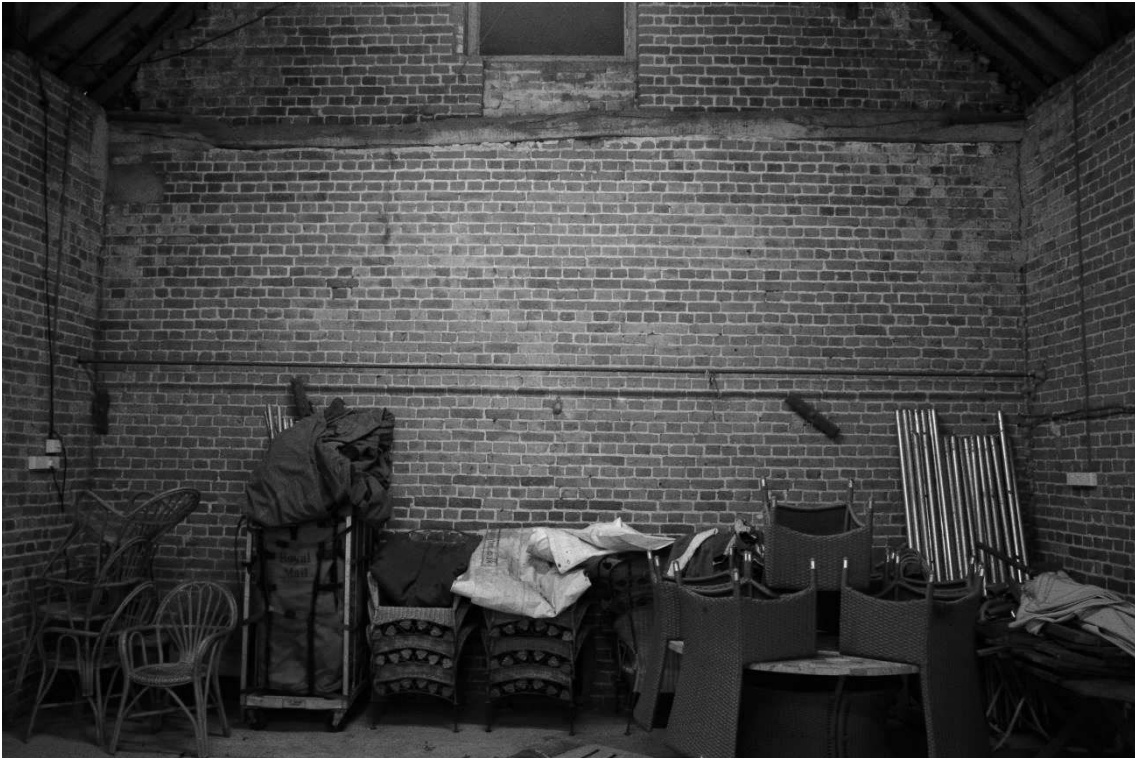
- 4.17 Further vertical cracking is evident in the rear left corner wall junction up to 10mm wide, which appears to be of some age. This appears to have been subject to previous remedial tying in the form of a 25mm diameter steel bar installed across the building close to the left hand gable wall some 2.2 metres above floor level. The left hand gable wall is otherwise in a satisfactory condition.

10. Internal view of left hand end wall

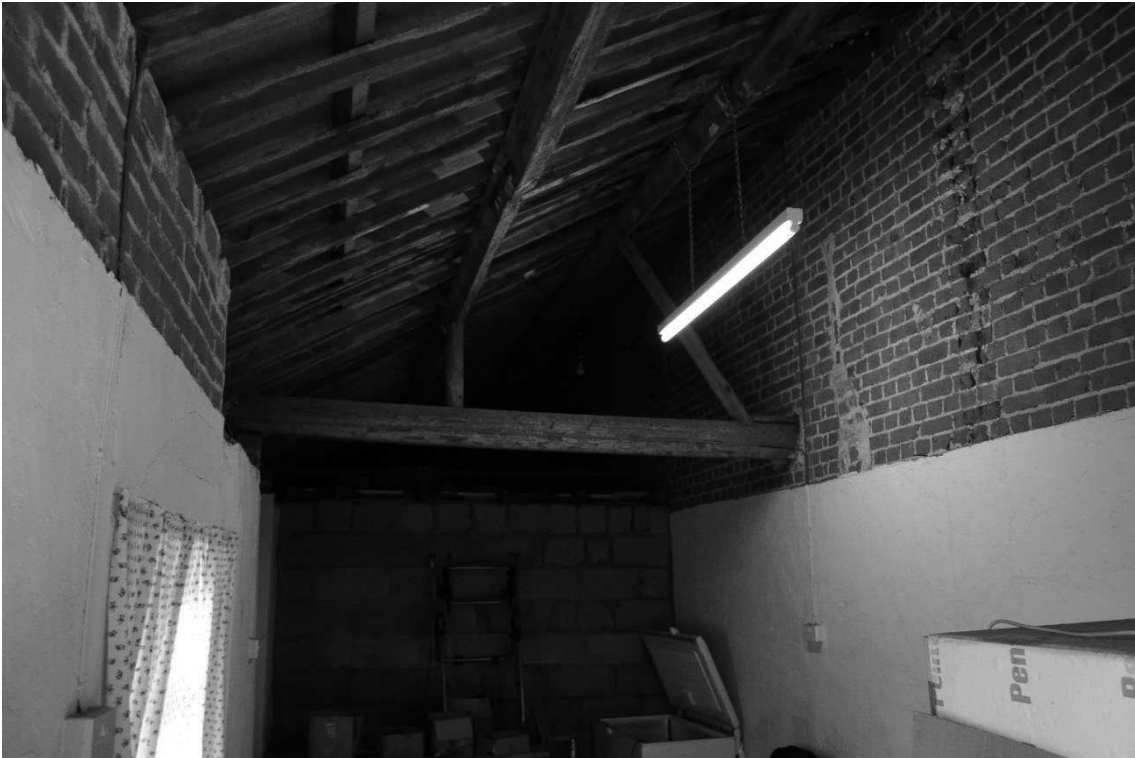
14. Rear offshoot roof looking towards right hand end
